Visual Problem Documentation

EXTERNAL ELEVATIONS

Bradley Stoke Leisure Centre Swimming Pool

InspectionNo: 1488 Report Date: 02/02/2011

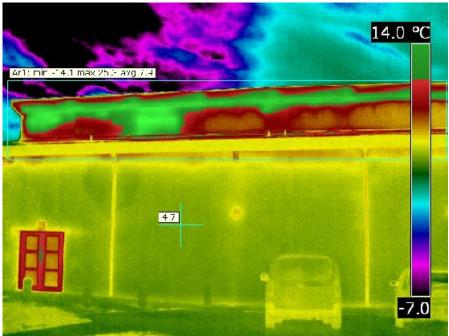
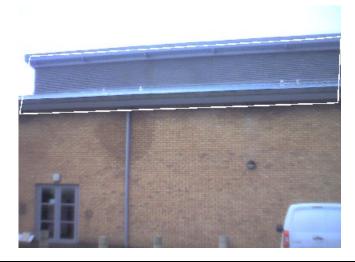
File: IR_1332A.JPG File: DC_1333.jpg

Decreased surface temperature at AR1 and AR2

What is the Cause: Suspected air leakage and thermal bridge from internal detail

Recommendations: Repair or replace seals and improve insulation
