Visual Problem Documentation

Stroma Technology Ltd
Rushenden - 42 First Avenue

Location/Equipment Information
Asset ID: - INTERNAL ELEVATIONS HALLWAY

InspectionNo: 1982
Report Date: 21/12/2012

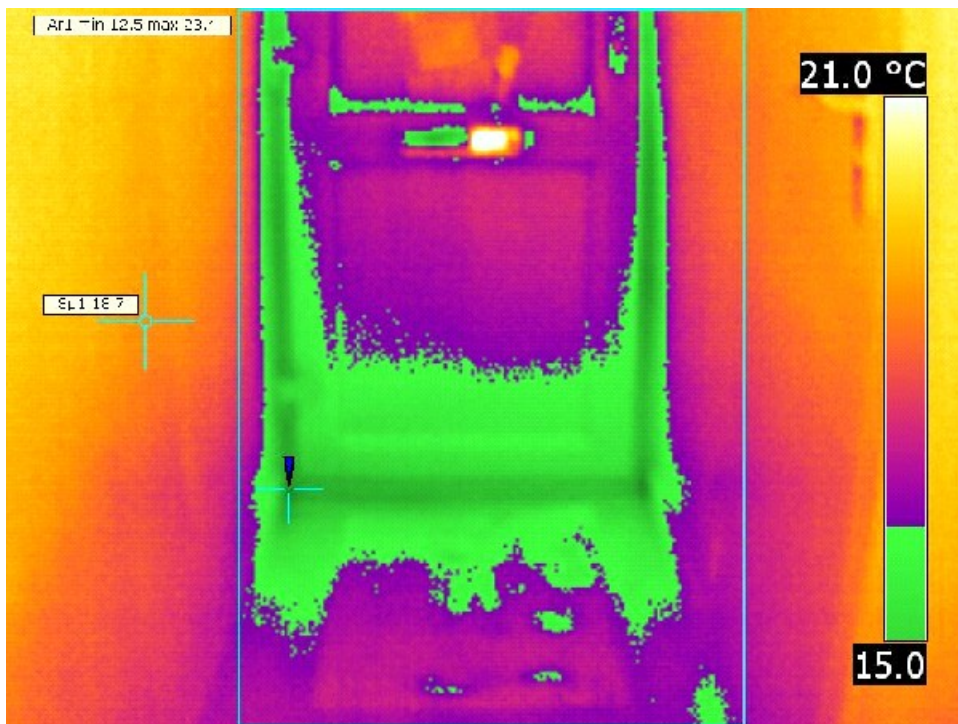
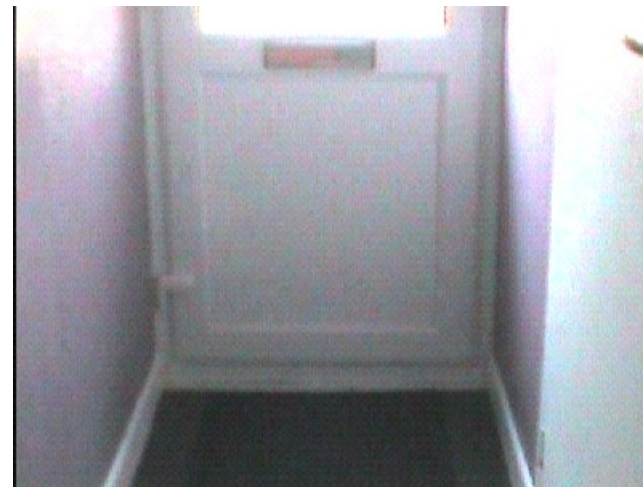
- Classification:** Buildings
- Observations:** Decreased temperature at AR1
- What is the Cause:** Suspected air leakage
- Recommendations:** Check seals and repair or replace where necessary
